PERFORMANCE OF ROOFINGS IN COLD CLIMATES

William C. Cullen

30 June 1965

Organic Building Materials Section
Building Research Division
Institute for Applied Technology

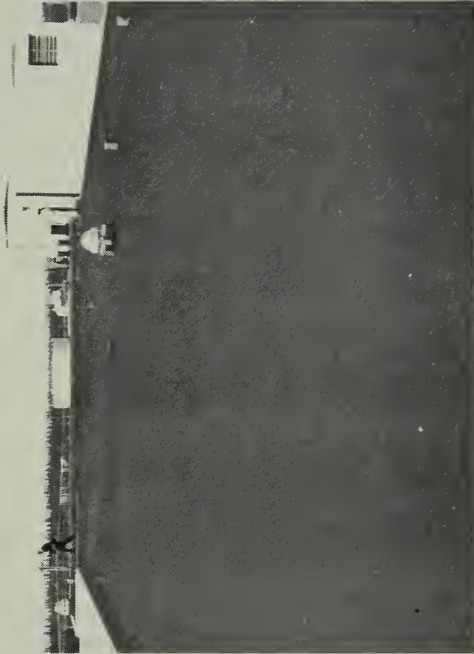
Concrete decks, both poured and precast, have been used frequently as the structural platforms for roofing systems on low slopes. Wood decks, both plywood and T & G planks, have also been used to a large extent especially on family housing units. In many cases a wood deck was constructed over an existing flat concrete deck to provide a sloping surface. A case in point is shown in Figure 2 which proved to be most successful.

FIGURE 2. WOOD DECK APPLIED OVER A FLAT CONCRETE DECK TO PROVIDE A POSITIVE SLOPE.

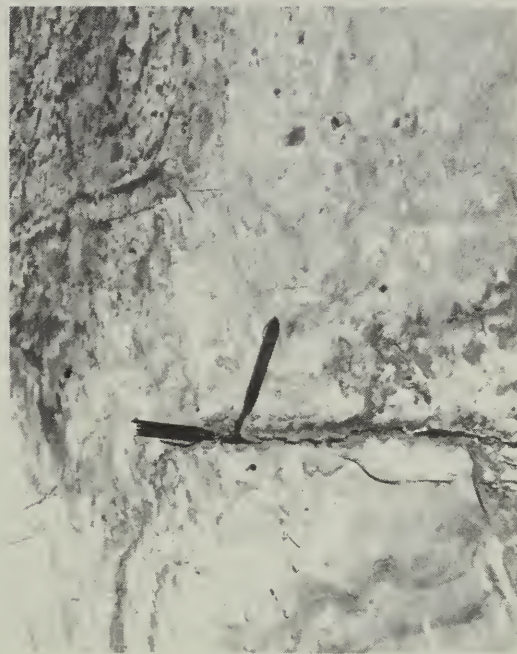
Investigations, by the author, of roofing failures in cold climates over a period of many years have revealed that membrane shrinkage has been an important factor in both membrane and flashing failures. It was therefore anticipated that this factor would be a frequent cause of roofing failures in Alaska. However, our observations indicated that thermal shrinkage was of minor concern when compared to other factors. In fact, only three cases were observed in which thermal shrinkage was suspect. Figure 4 shows a serious failure attributed to thermal shrinkage in the form of a roof split which was observed on a cold storage warehouse. Figure 5 shows a repaired area which is again showing signs of a splitting failure due to thermal movement.

FIGURE 4. ROOF MEMBRANE SPLIT ATTRIBUTED TO THERMAL SHRINKAGE.

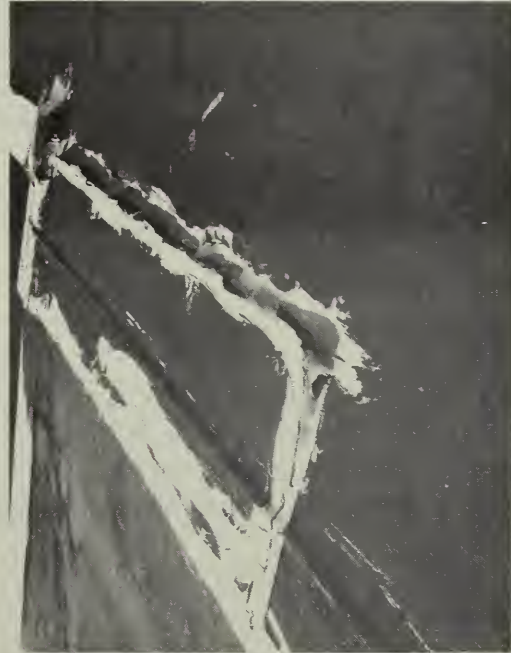
Inadequately designed, improperly installed and defective flashings were observed on roofs located at each installation. In our opinion, these deficiencies accounted for a large percentage of the reported failures. Figure 7 shows a serious failure which is typical of such a design at the flashing of an earthquake joint, which resulted in leakage. This was the only failure on a roof which otherwise provided good service for over 5 years. We believe this to be a poorly designed flashing system for an expansion joint.

FIGURE 7. DEFECTIVE FLASHING AT EARTH-QUAKE JOINT AFTER UNSUCCESSFUL ATTEMPTS TO REPAIR.

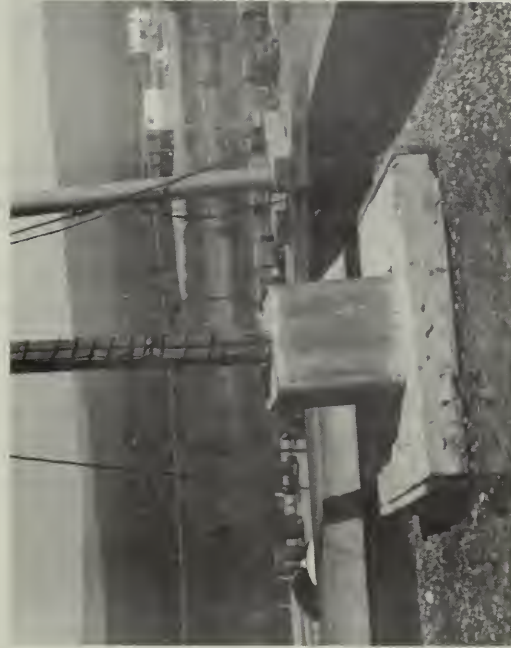
The unauthorized installation of antennae have also been the cause of leakage in many roofing systems. Figure 8 illustrates an extreme case where coping, roofing and flashing were punctured.

FIGURE 8. UNAUTHORIZED INSTALLED ANTENNAE WHICH RESULTED IN COPING, FLASHING AND MEMBRANE FAILURES.

Antenna installation should be made under the supervision of the post engineering personnel.

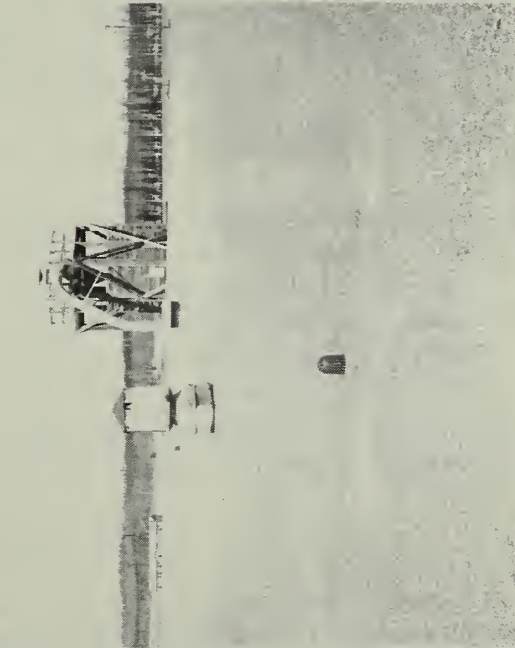
FIGURE 11. GRAVEL SURFACED ROOF AFTER
14 YEARS SERVICE, ANCHORAGE, ALASKA.

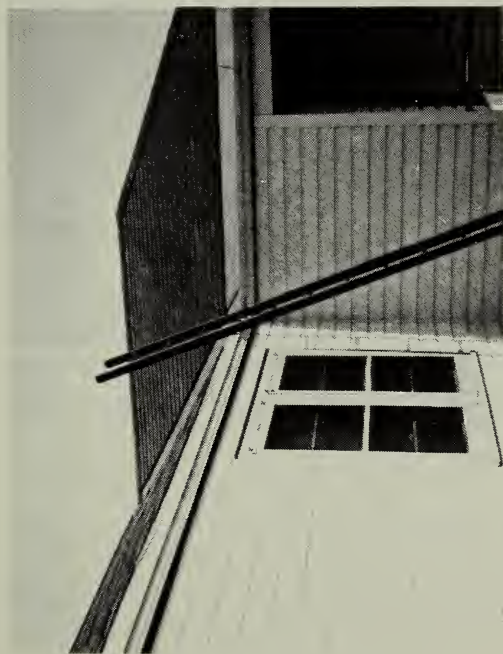
There was complete agreement that roofing systems on steep slopes have a history of excellent service in Alaska regarding watertightness and durability. Figures 13, 14, 15, and 16 show roofings which are typical of those which have served well. These include asbestos-cement, asphalt shingles, roll roofings, metallic shingles, and various other metal roofings. In fact, copper shingles which were observed in the Fairbanks area were still giving adequate service after 24 years service. This is considered excellent service for any roofing material in any climate.

FIGURE 13. ASPHALT SHINGLES ON A 6-INCH IN 12-INCH SLOPE IN EXCELLENT CONDITION AFTER 17 YEARS EXPOSURE.

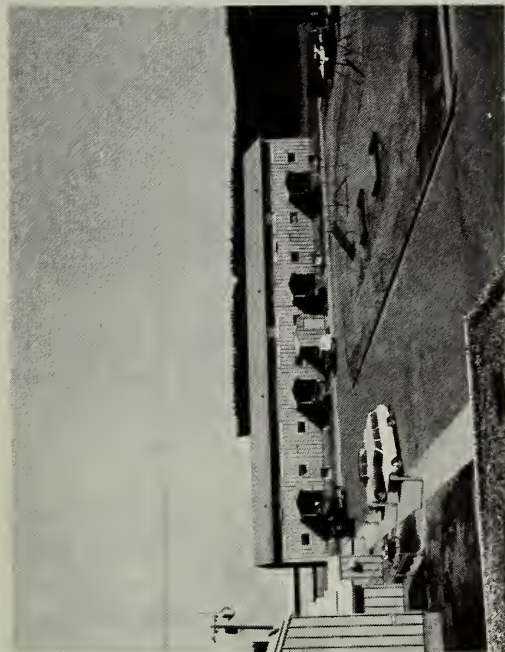
FIGURE 14. ASPHALT SHINGLE ROOF ON FAMILY HOUSING BUILDING.

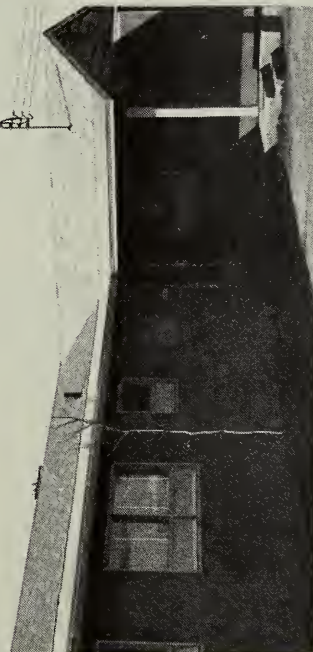
FIGURE 15. ASPHALT SHINGLES, SPOT-CEMENTED, ON FAMILY QUARTERS AFTER 5 YEARS EXPOSURE. NOTE METAL EAVE STRIP.

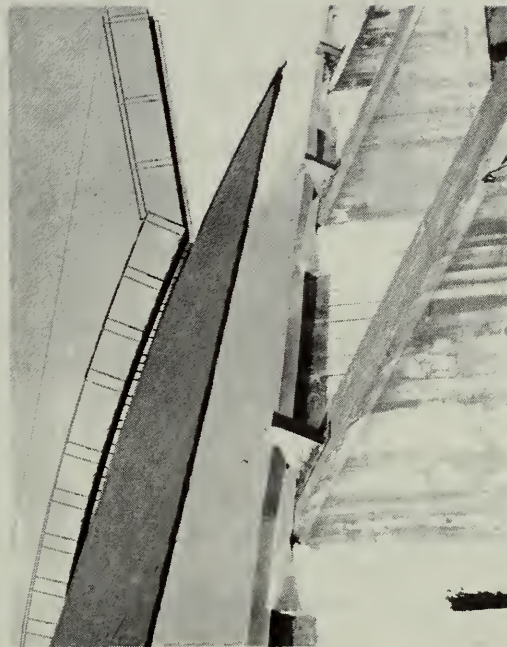
Glaciation and formation of ice dams are problems common to steep roofs in cold climates. Glaciation, although not directly connected with roof performance must be considered in terms of the hazard it presents to life and property (including roof damage). On the other hand, the formation of ice dams at the eave of a roof frequently cause leakage where non-continuous roofings are involved (shingle type). A metal eave strip varying in width from 12 inches to 3 feet or more has been used (Figures 13 to 16) to reduce the potential hazards.

FIGURE 16. MINERAL-SURFACED ROLL ROOFING ON HANGAR ROOF AFTER 7 YEARS EXPOSURE. NOTE THE WIDE METAL EAVE STRIP USED TO SHED ICE AND SNOW.

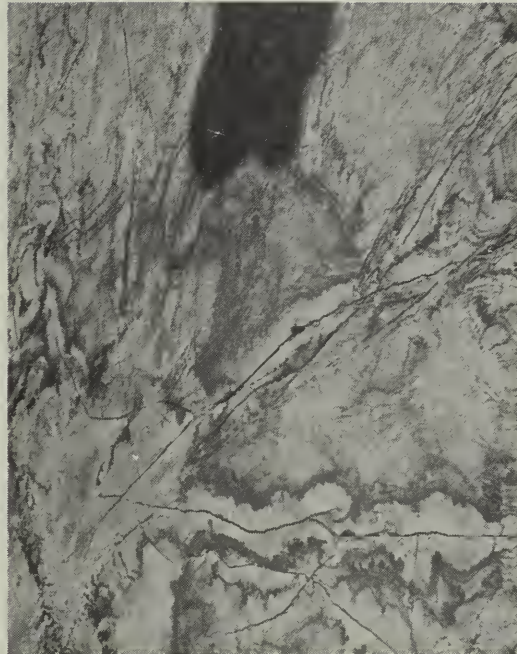
FIGURE 20. SURFACE CRACKING OF AN ASPHALT EMULSION ROOF COATING APPLIED OVER A THICK COATING OF HOT ASPHALT.
